TECHNICAL MEMORANDUM 98/202

**DEFECT CONDEMNATION
FOR
SUBMARINE PRESSURE HULL WELDS**

**Defence
Research
Establishment
Atlantic**

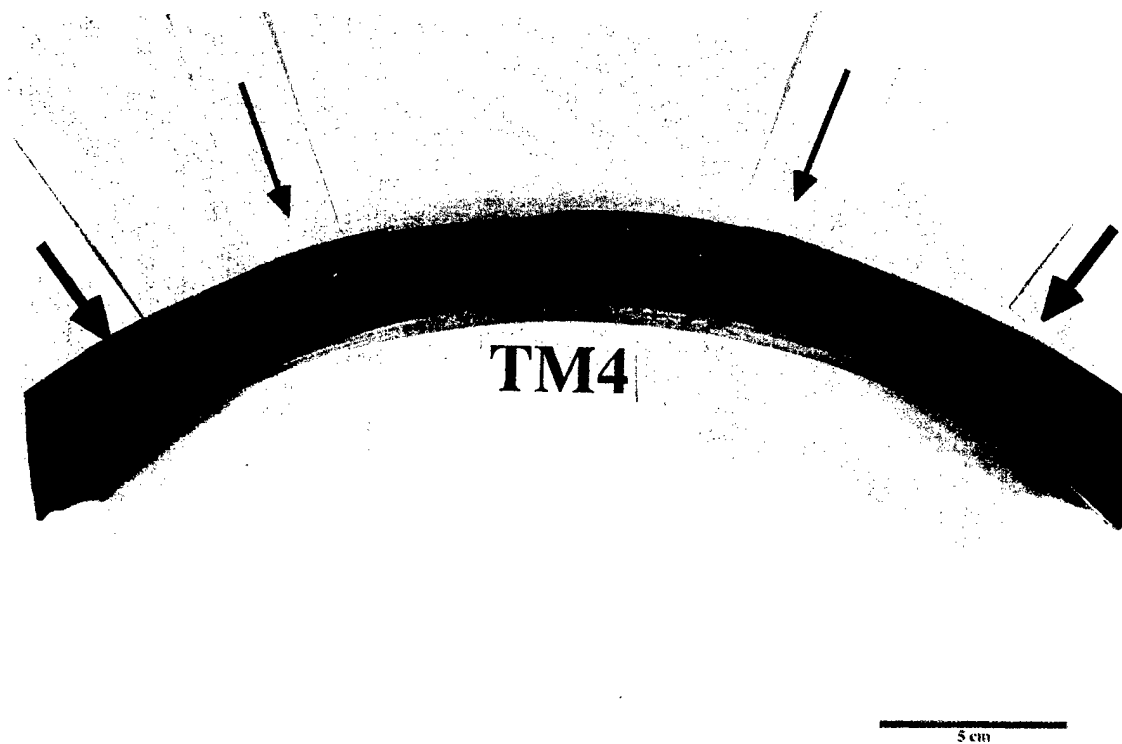
Figure 6.1.1: Fracture surface of panel TM-4 containing root flaws. The arrows indicate extremes of initial and final flaws.

Figure 6.1.1 indicates a typical fracture resulting from the presence of root flaws. The thinner arrows indicate the length of the initial flaw while the thicker arrows show the extent of the final flaw.

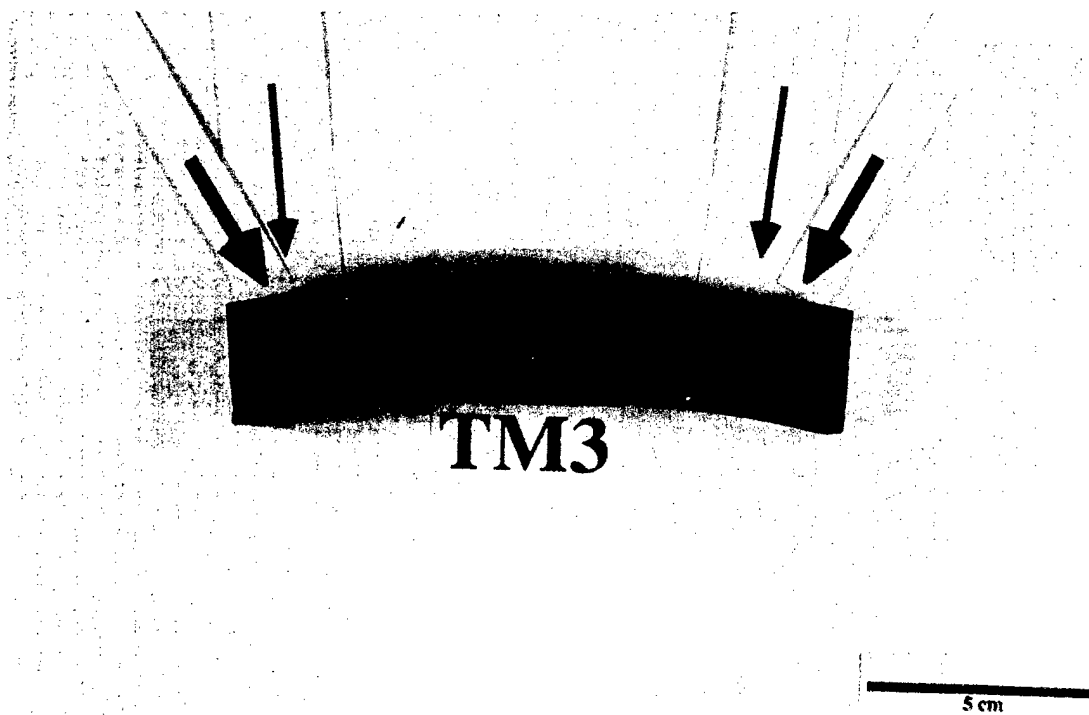
Figure 6.1.2: Fracture surface of panel TM-3 containing cap flaws. The arrows indicate extremes of initial and final flaws on the convex side.

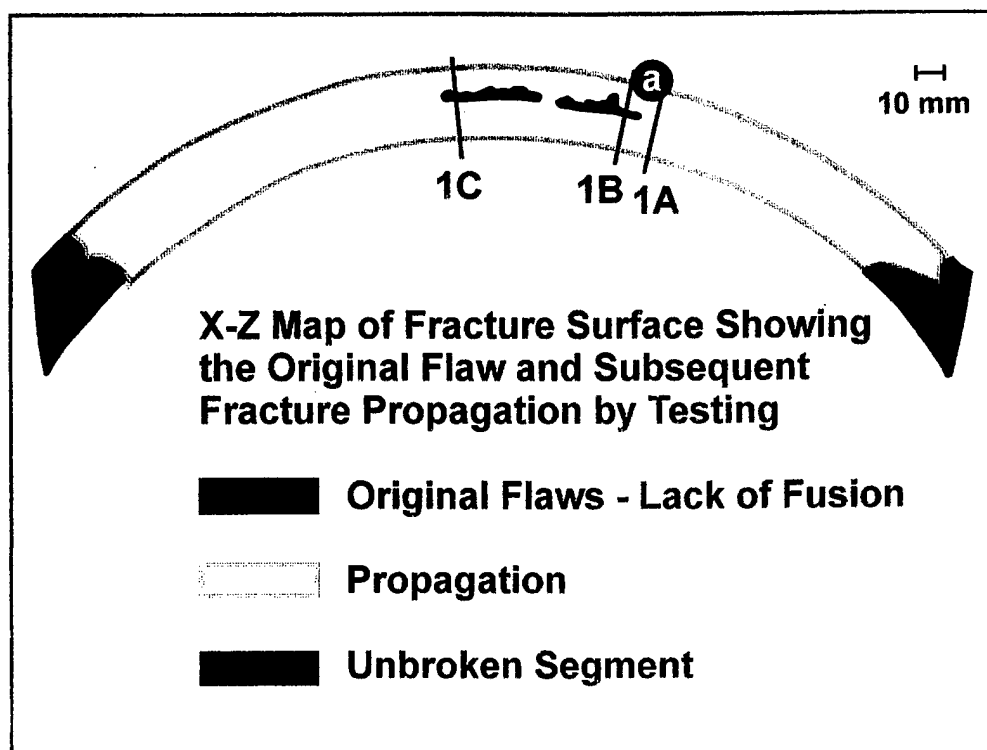
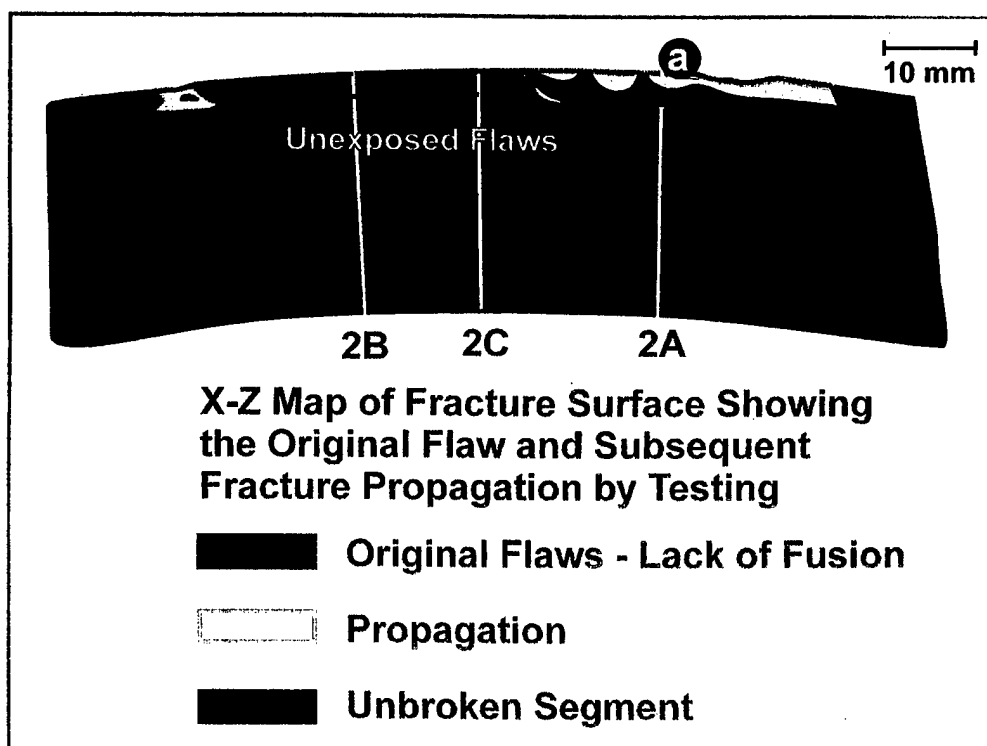
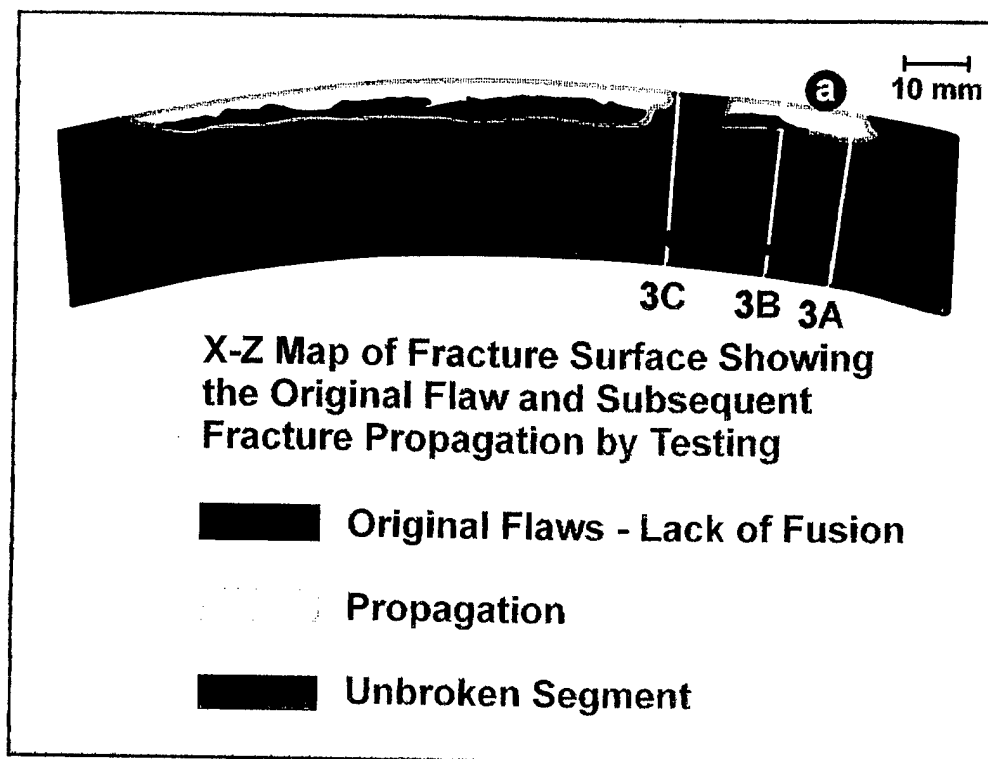
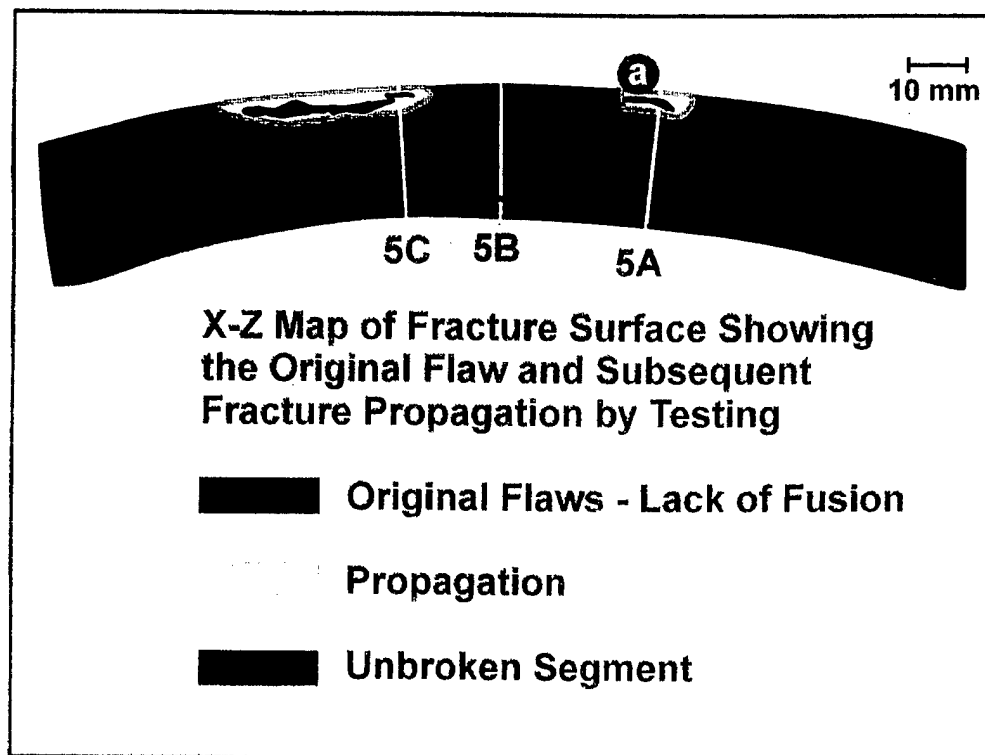
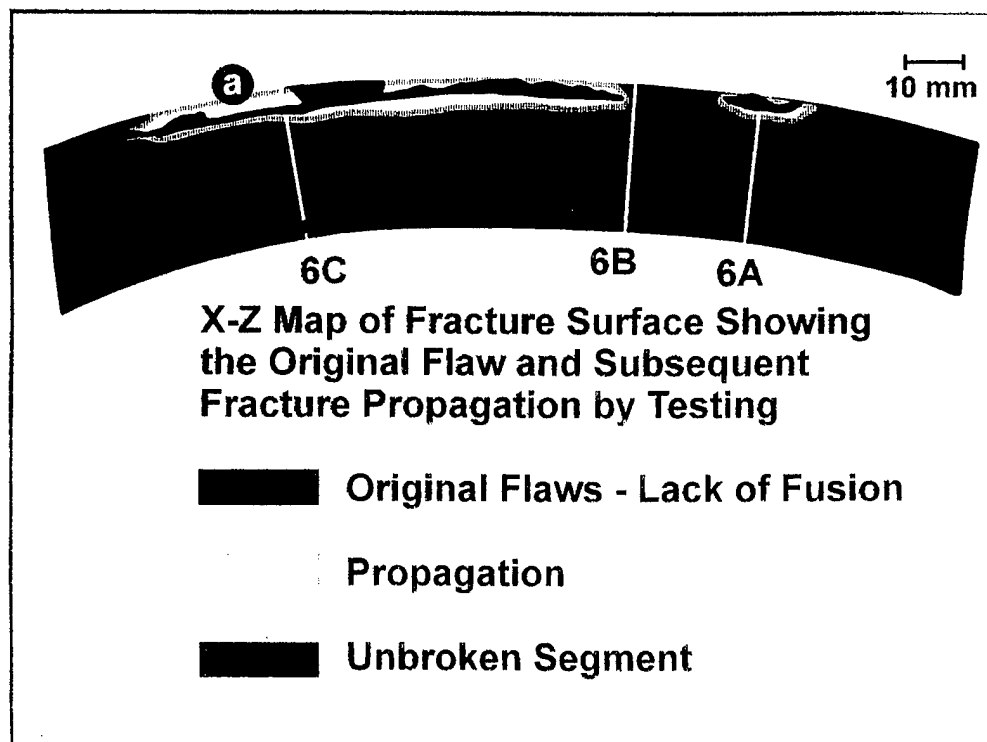
Figure 6.1.3(a): X-Z map for panel TM-1

Figure 6.1.3(b): X-Z map for panel TM-2

Figure 6.1.3(c): X-Z map for panel TM-3

Figure 6.1.3(d): X-Z map for panel TM-4

Figure 6.1.3(e): X-Z map for panel TM-5

Figure 6.1.3(f): X-Z map for panel TM-6

Table 6.1.1 indicates the lengths, approximate location in relation to the nearest surface, and the depths of the initial flaws as observed on the fracture surfaces. Figures 6.1.3(a) to 6.1.3(f) show the schematics of these results.

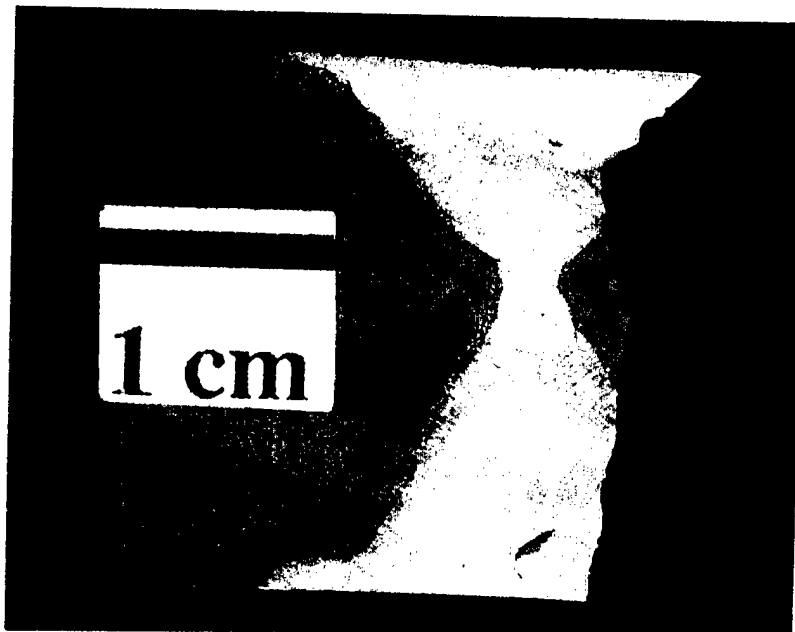
Figure 6.3.4: Macrograph of cross-section (from TM-5) at location that exposes the initial flaw at the convex side of the fracture face. (Top side is the convex surface).

The cross-sectional metallographs of panels with cap flaws indicate that the initial flaws delineated in the fracture face with a featureless appearance were indeed in the cap passes of the weld and that the propagation occurred in the weld metal on both sides of the initial flaw in the radial direction (see Figure 6.3.4). These fractures did not expose a continuous initial flaw on the fracture surfaces (see Table 6.6.1). Cross-sections were therefore extracted in all of these fractures at positions that do not show the propagation of the flaw. Using these an attempt was made to establish if the flaw was indeed continuous on the convex side of the panel. They showed that these defects are at different interpass locations. Therefore, compared to root defects which are associated with the single root pass, the cap defects are associated with one or more of the cap passes.

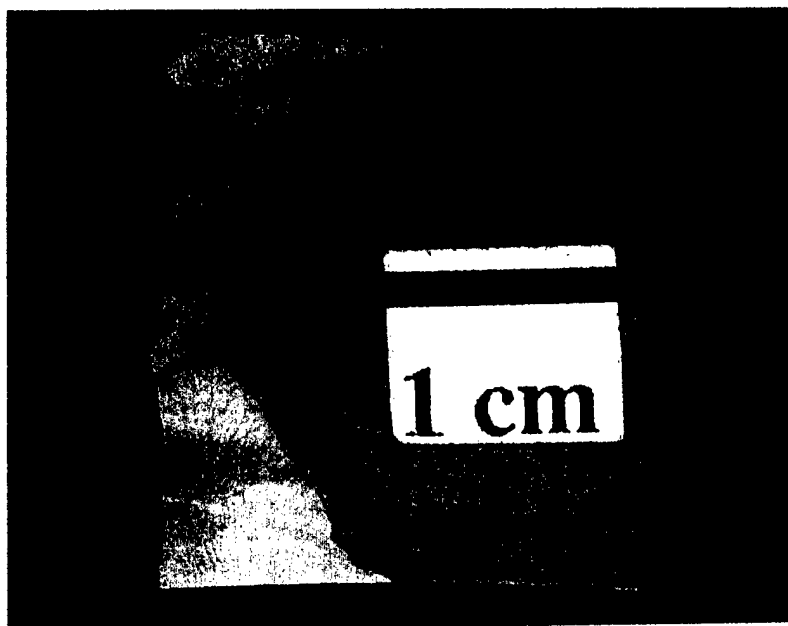
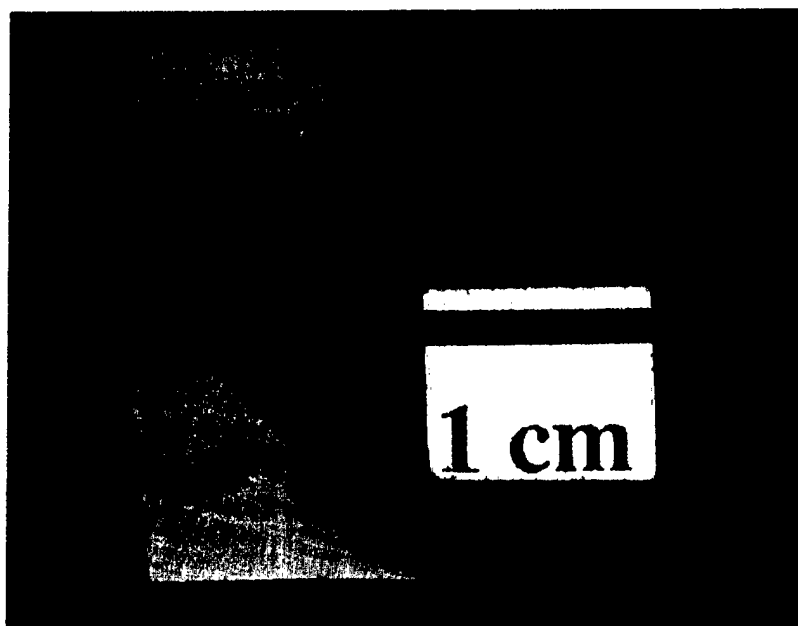
Figure 6.3.5: Macrographs of cross-sections (from TM-2); one from a location that exposes the initial flaw at the convex side of the fracture face (a), and the other from a location that does not expose the initial flaw, (b). (Top side is the convex surface).

Two cross-sections were also taken in panel TM-2 from the fracture surface portion that did not expose the flaw on the fracture surface but within the two exposed flaws. These cross-sections displayed cap flaws that did not propagate but were aligned with the flaw that propagated to the convex surface. Compared to the other three panels that indicated the cap flaws to be non-continuous, TM-2 on the other hand, had a continuing cap flaw on the convex side that was not exposed to the fracture surface at least at the two locations where macrographs were prepared (Figure 6.3.5). These flaws are presented as a broken line at these locations in the X-Z map.

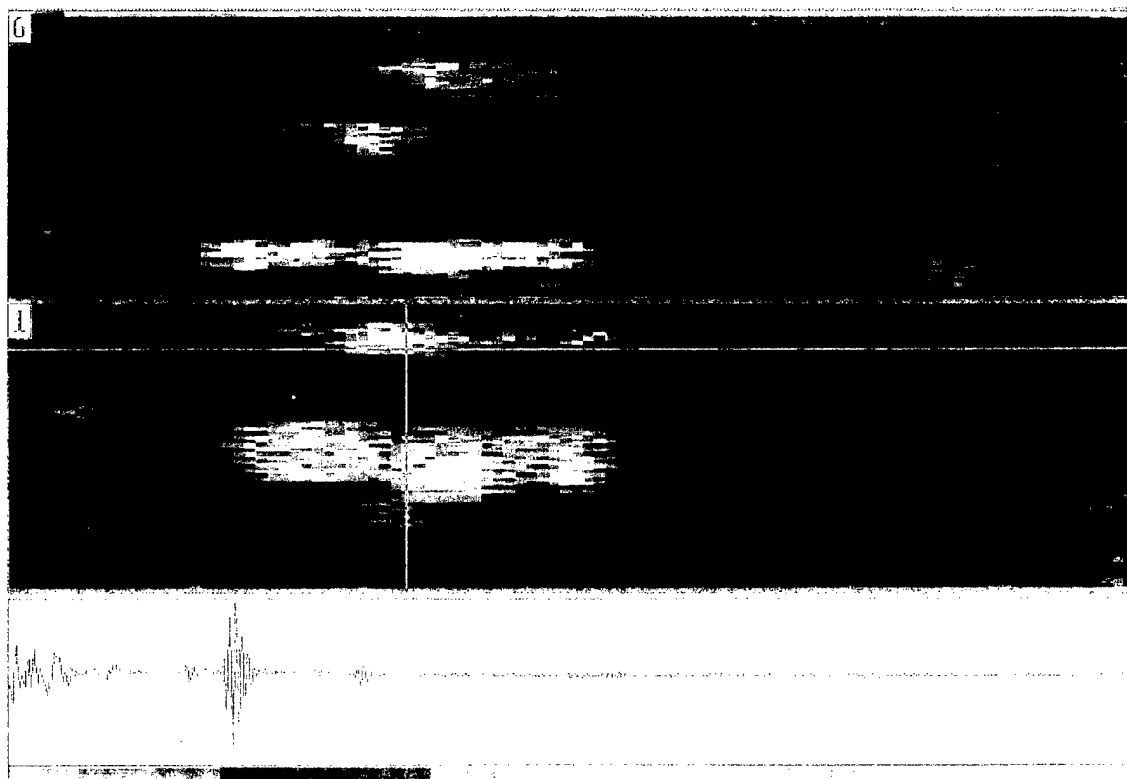
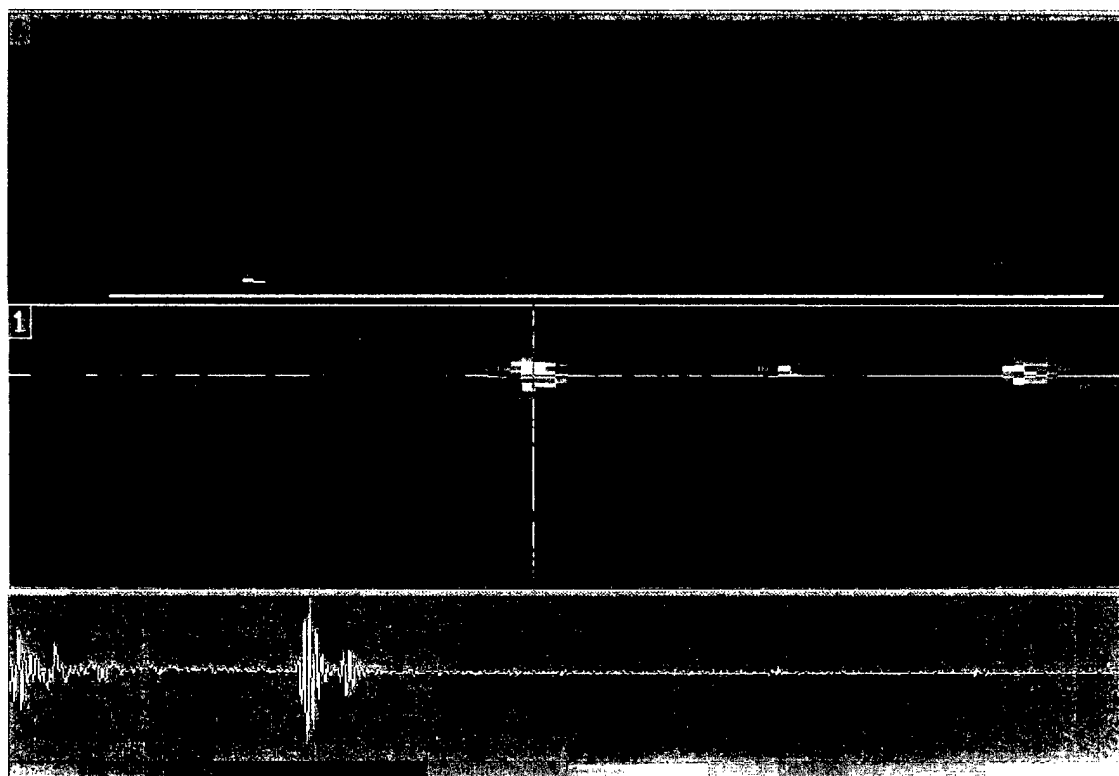
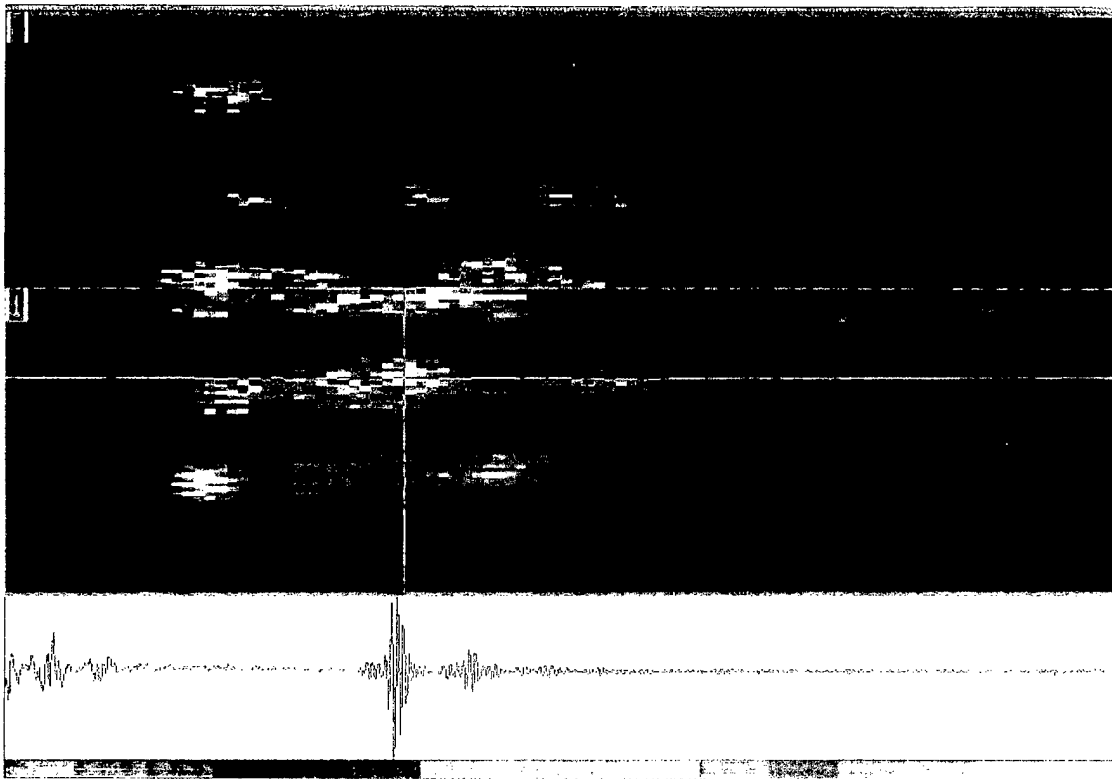
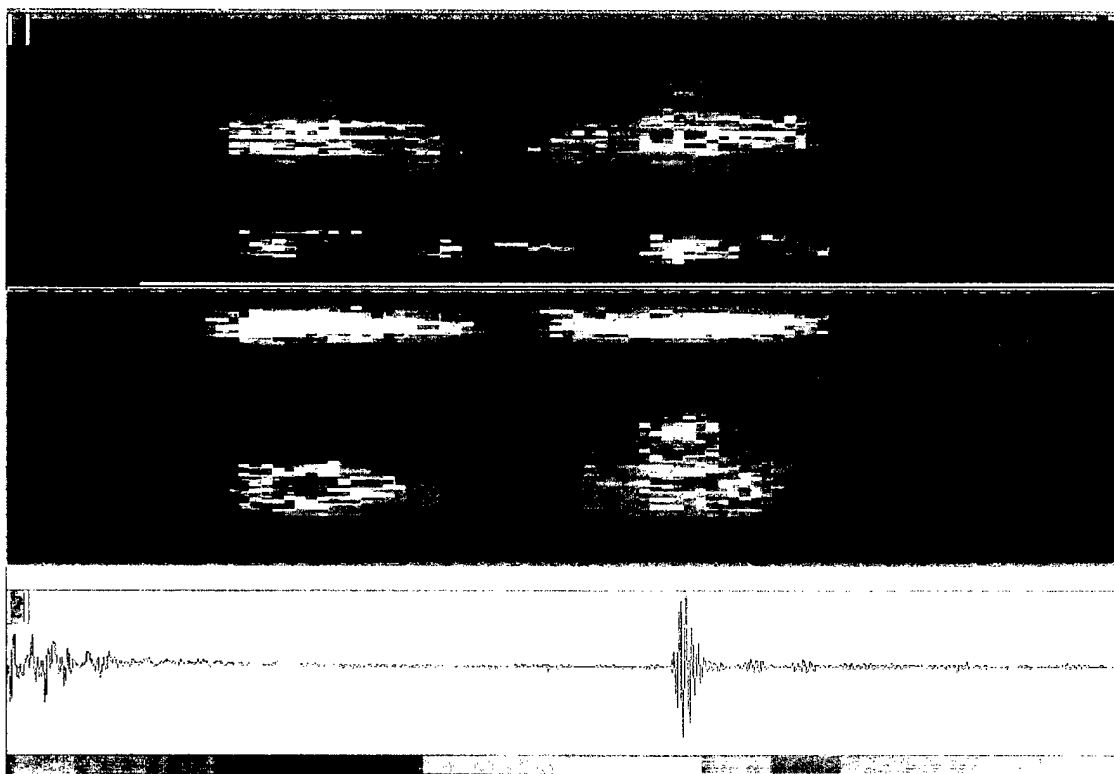
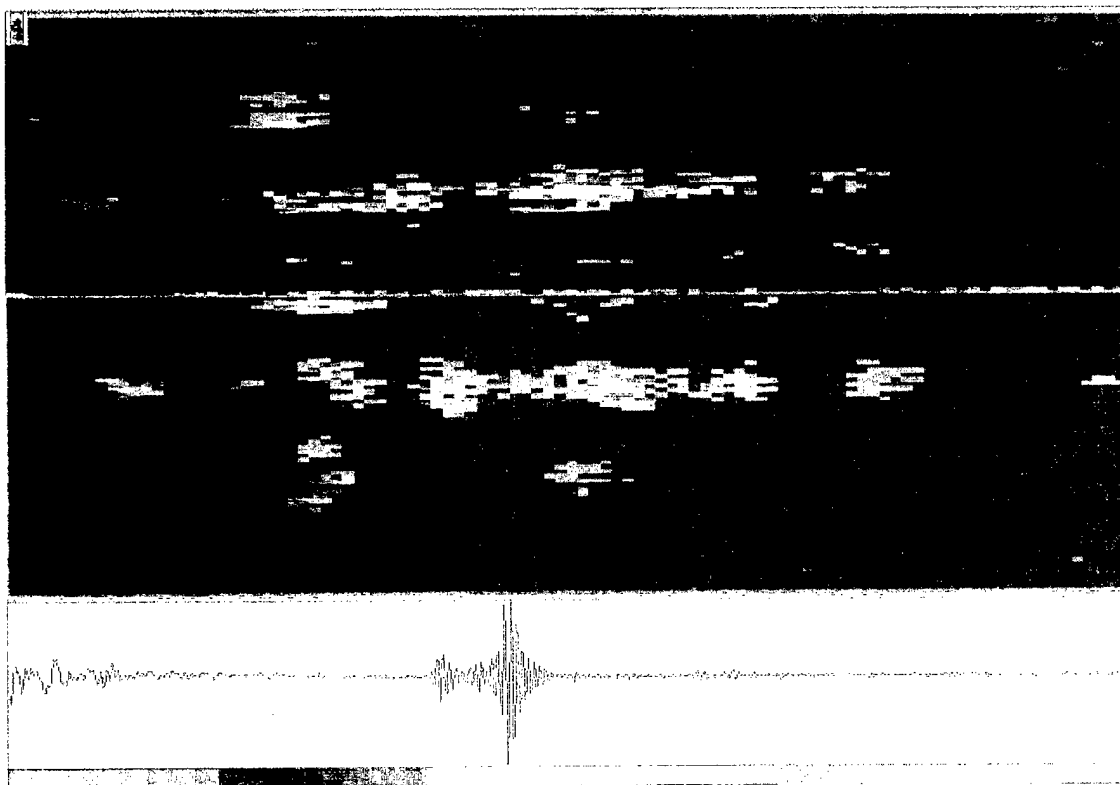
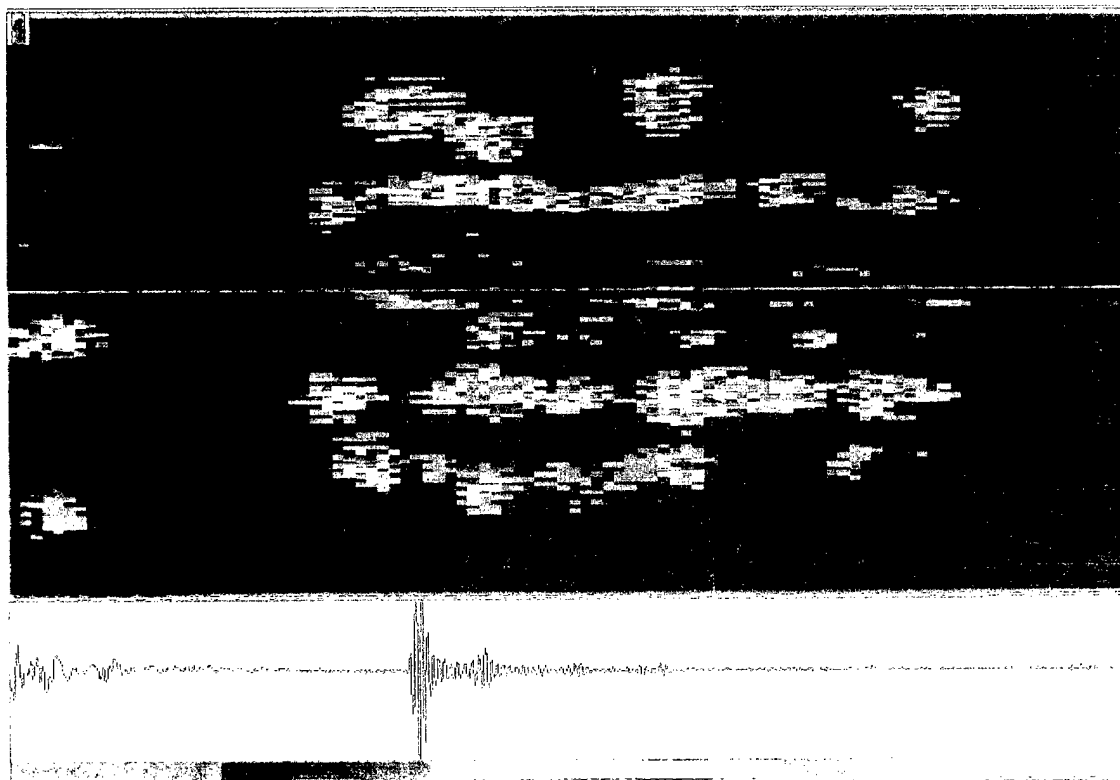
APHIUS Printouts

Figure A-1: Computer-aided ultrasonic scan for plate TM-1.

Figure A-2: Computer-aided ultrasonic scan for plate TM-2.

Figure A-3: Computer-aided ultrasonic scan for plate TM-3.

Figure A-4: Computer-aided ultrasonic scan for plate TM-4.

Figure A-5: Computer-aided ultrasonic scan for plate TM-5.

Figure A-6: Computer-aided ultrasonic scan for plate TM-6.

APHIUS produces longitudinal B-scans which show the depth of defects. Transverse B-scans indicate the location of defects in the weld profile. APHIUS is referred to as intelligent because it can help the operator distinguish between tolerable defects and those calling for material condemnation.

A top view printout of the APHIUS results from each of the six plates is found in Annex A.
